# TEST REPORT

REPORT No.:  
CTK-2026-00014  
Page (1) / (25) pages

NETWORK CAMERA / XNV-A8016R

NEMA TS 2-2013 2.2.7.3 Test C ~ 2.2.7.8 Test H,  
NEMA TS 2.2.8, NEMA TS 2.2.9

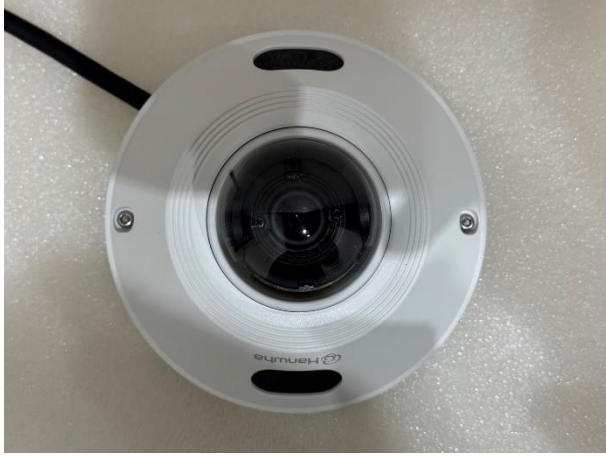
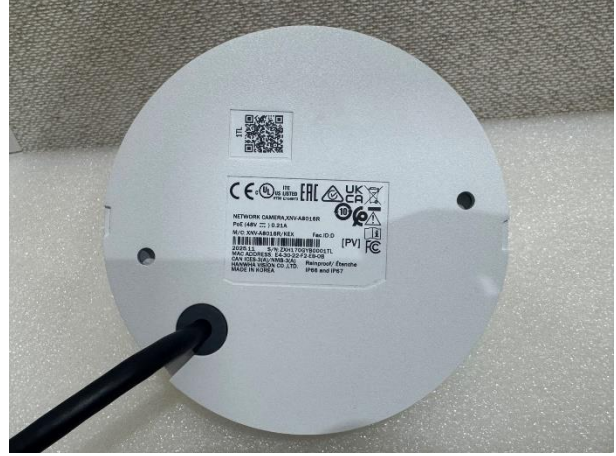
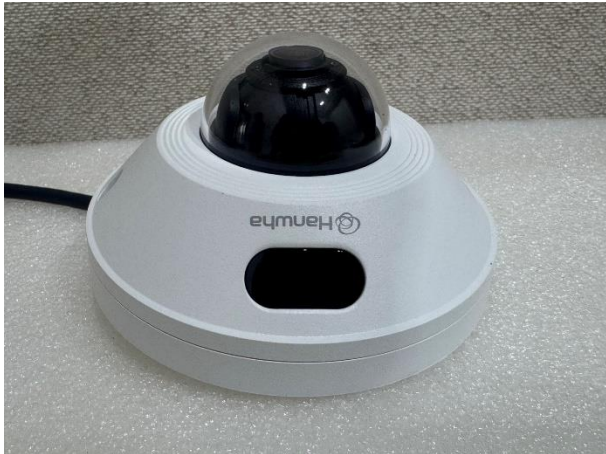
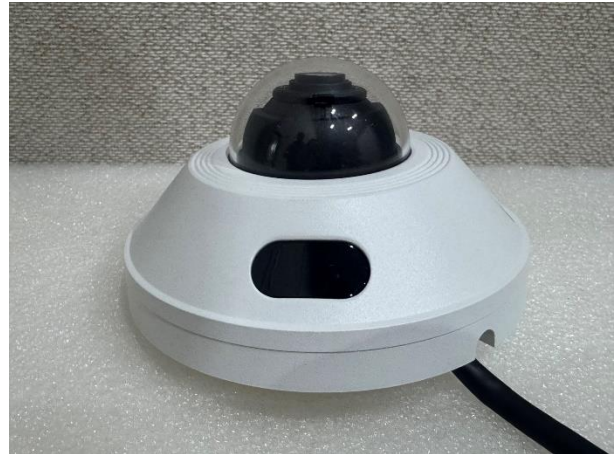
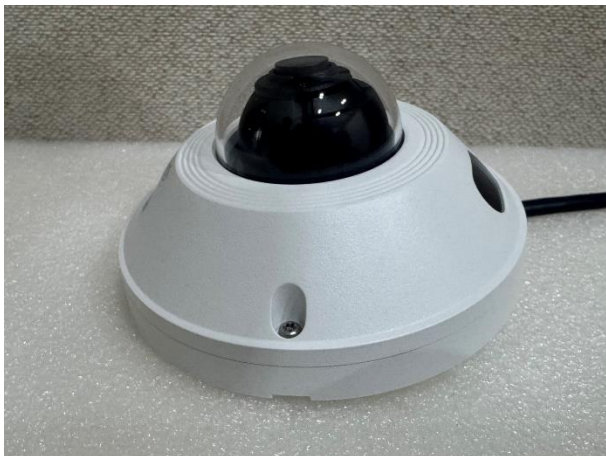
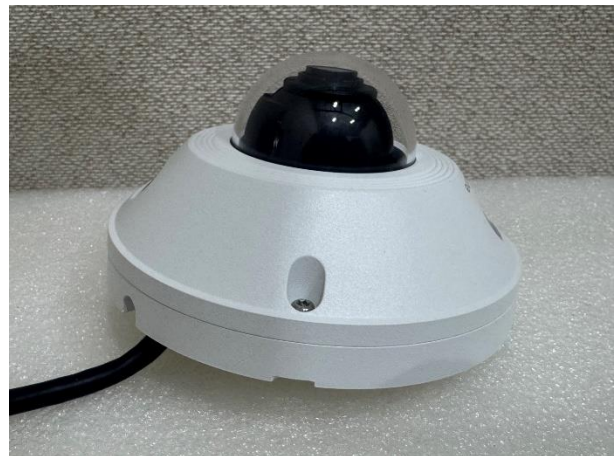
### 2.3.1 Test sample

## 2.3 Pre-test product images

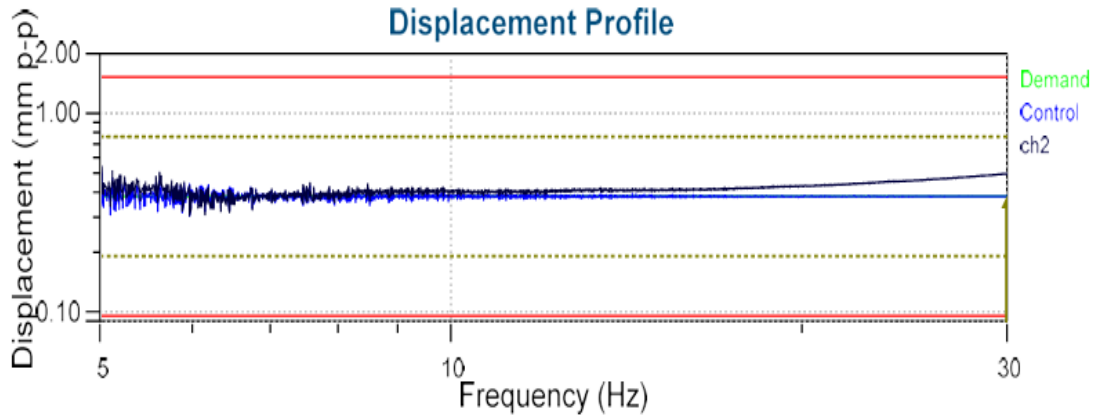
#### Resonant search Test

- Sample status : unpackaged / not in operation
- Applied waveform : Sine
- Frequency(Hz) : 5 ~ 30
- Double amplitude displacement (inch) : 0.015
- Sweep rate(Sweep/min) : 12.5

12 09, 2025 15:40:1: Level 1) 100 %      Output: 0.07026 Volts pea      NEMA TS-2 2.2.8 - search.  
 Demand: 0.381 mr      Level Time: 0:12:3      Frequency: 30 H;  
 Control: 0.3815 mn      Total Time: 0:12:3t      End of Sweep Tes

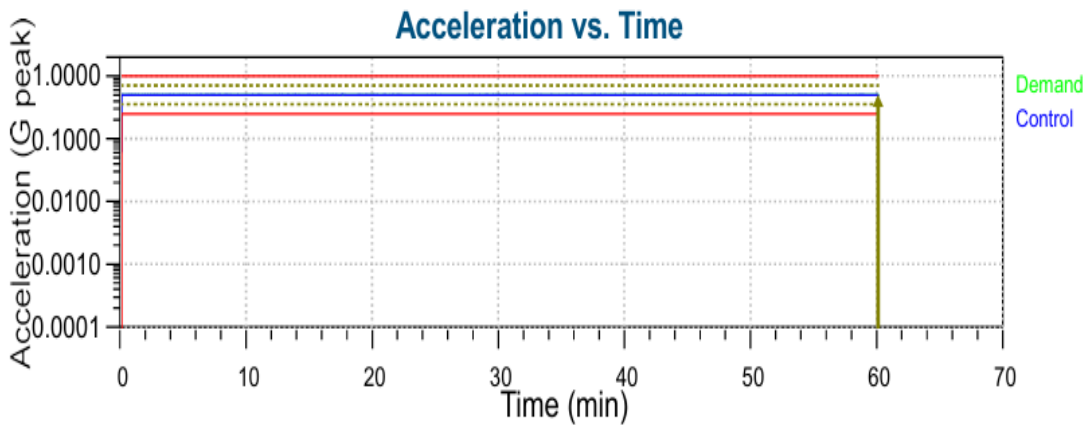
#### Endurance Test

- Sample status : unpackaged / not in operation
- Applied waveform : Sine
- Frequency(Hz) : 30 or 3.2.2 Test results
- Acceleration(G) : 0.5
- Applicable axis : X, Y, Z
- Test time(h) : All 3(Each axis 1)
- Evaluation items
  - Check for mechanical damage before and after testing
- Test methods
  - Vibrate the test unit in each plane at its resonant frequency for a period of 1 hour at an amplitude resulting in 0.5 g acceleration. (test profile)
  - When more than one resonant frequency has been recorded in accordance with Section 1.2 Item 4, the test period of 1 hour shall be divided equally between the resonant frequencies.
  - The total time of the endurance test shall be limited to 3 hours, 1 hour in each of three mutually perpendicular planes.

12 09, 2025 16:40:29 Level 1) 100 % at 30 Hz      Output: 0.051 Volts peak      NEMA TS-2 2.2.8 - 2  
 Demand: 0.5 G      Level Time: 1:00:00      Frequency: 30 Hz  
 Control: 0.5 G      Total Time: 1:00:07      End of Timed Test

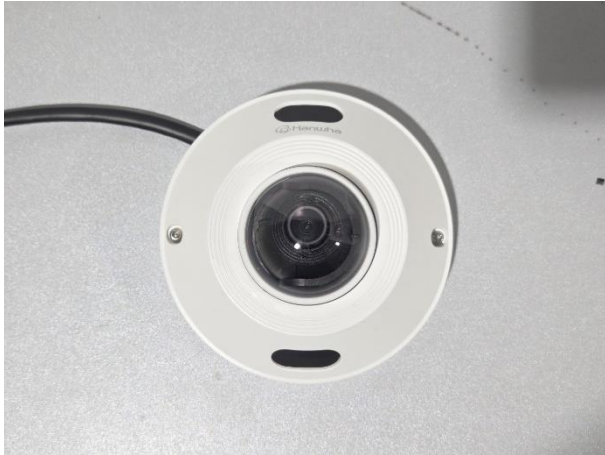
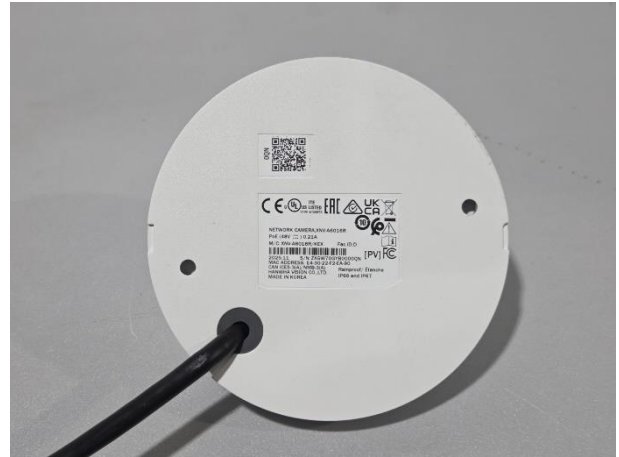
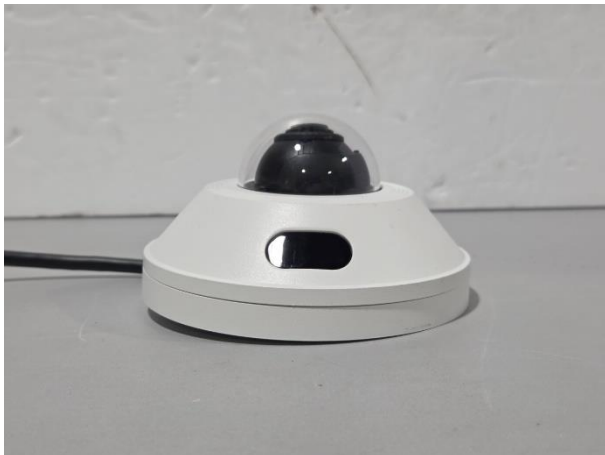
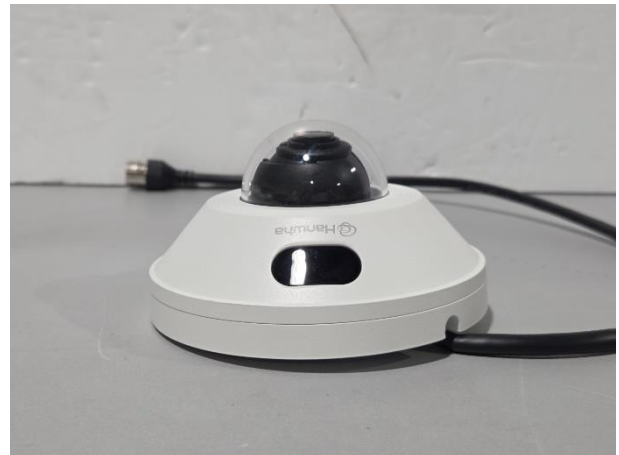
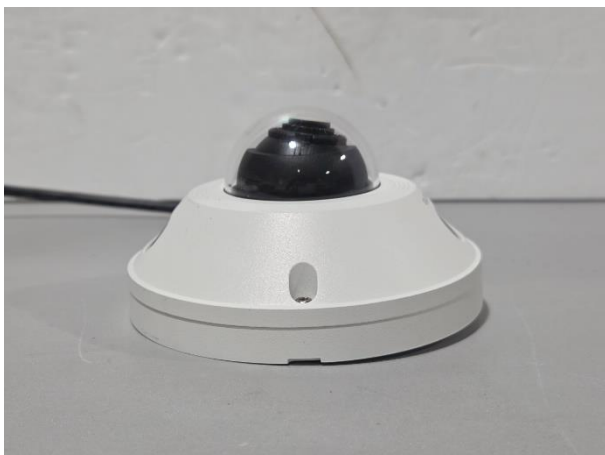
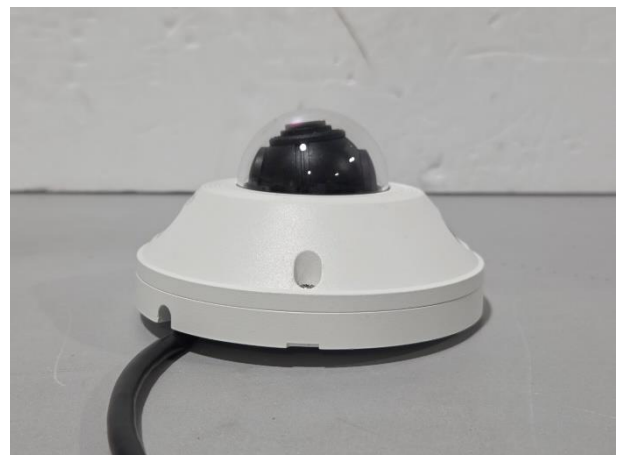
### 5.6.1 Test sample

## 5.6 Post-test product images

Evaluation Criteria		Test Results	Comment
Shock(impact) Test	Before	Normal	
	After	Normal
