# TEST REPORT

REPORT No.:  
CTK-2026-00010  
Page (1) / (12) pages

NETWORK CAMERA / XNV-A9016R

IEC 62262:2002+AMD1:2021

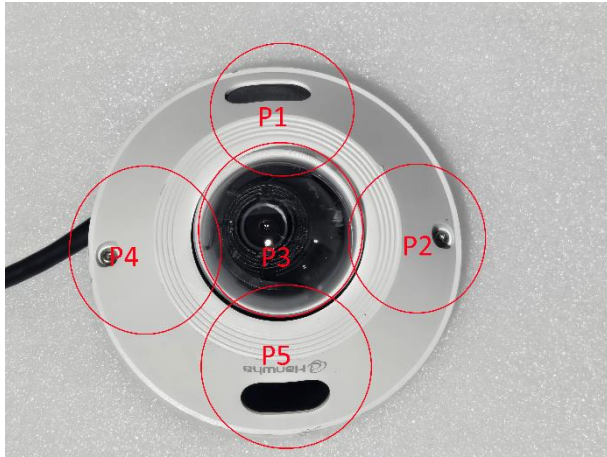
Check the hit area the test\_1

Check the hit area the test\_2

Check the hit area the test\_3
